CONTENTS

No. 3

Issue 3.

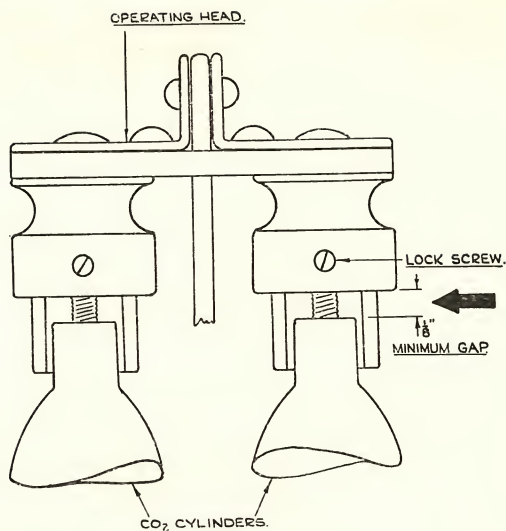
FIGURE 1

TYPE 47 LIFEJACKET.
NOTE: TYPE 45 LIFEJACKET HAS A SINGLE
CYLINDER WITH A MODIFIED OPERATING HEAD.

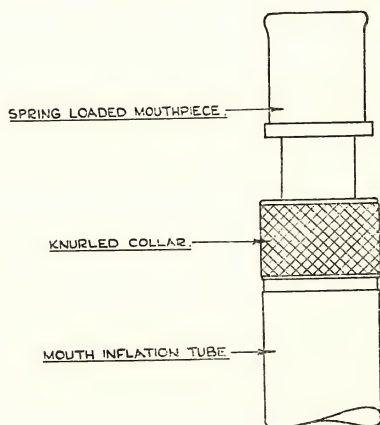
FIGURE 2

TYPE 47 LIFEJACKET, MK. 2.
MOUTH INFLATION ASSEMBLY.
